## Structural Damages Caused by Tatsumaki

By Hatsuo ISHIZAKI and Yoshihito TANIKE

### Abstract

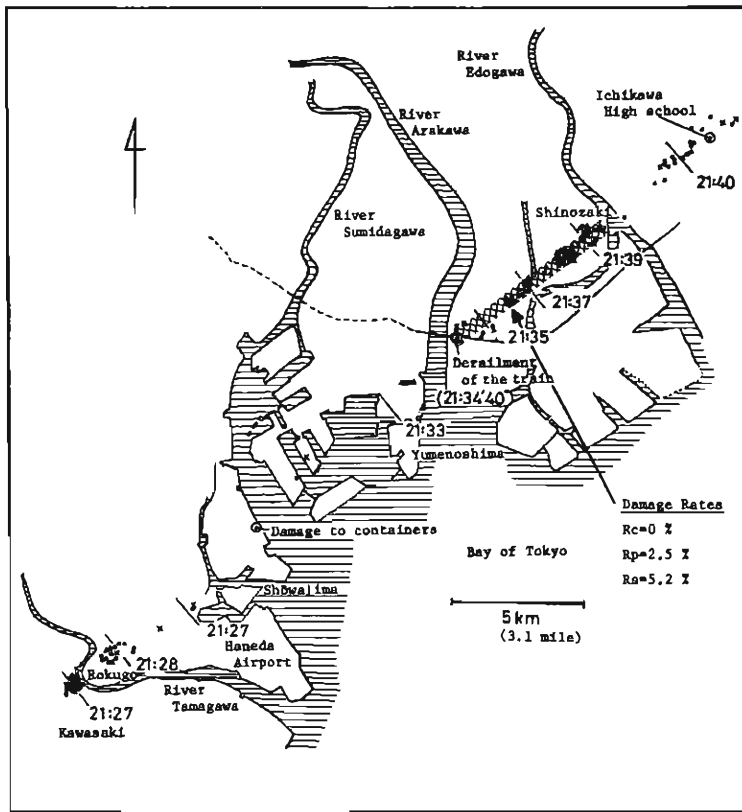
Fig. 3. The damaged zone caused by the Tatsumaki in a mature state.

While the damage rates of the present Tatsumaki in the Edogawa District which is between the Arakawa River and the Edogawa River, where the Tatsumaki was in a mature state, the damage rates within the damaged zone of the Tatsumaki were  $R_c=0\%$ ,  $R_p=2.5\%$  and  $R_s=5.2\%$  respectively (see **Fig. 3**). These rates were obtained by dividing the number of damaged houses by the total number of houses in the area inflicted by the Tatsumaki, that is the area with a width of 0.4 km and a length of 5.7 km along the contour line of the damaged zone which is indicated by oblique lines in **Fig. 3**. The recorded maximum peak gust of the Tatsumaki was 52 m/sec at two observation points. The observation points were a short distance away from the center of the path and the true maximum peak gust is likely somewhat higher than this value. If the wind exceeds 52 m/sec in a typhoon, the damage rates of  $R_c$ ,  $R_p$ , and  $R_s$  will be above 5%, 20% and 50% respectively as shown in **Table 2**. The present Tatsumaki damage is far less than those of typhoons of the same wind speed. The difference of the damage rates between Tatsumaki and typhoons is due to the short duration of the maximum peak gust. A high wind of a typhoon continues for several hours whereas in the case of a Tatsumaki it continues only for a few seconds. Furthermore, the area afflicted by the peak gusts in a typhoon is 10–15 km wide, while it is only about a hundred meters in the case of a Tatsumaki. With respect to the structural aspects, horizontal forces are mainly dominant in typhoon winds, whereas up lift forces are as strong as horizontal forces in Tatsumaki winds.

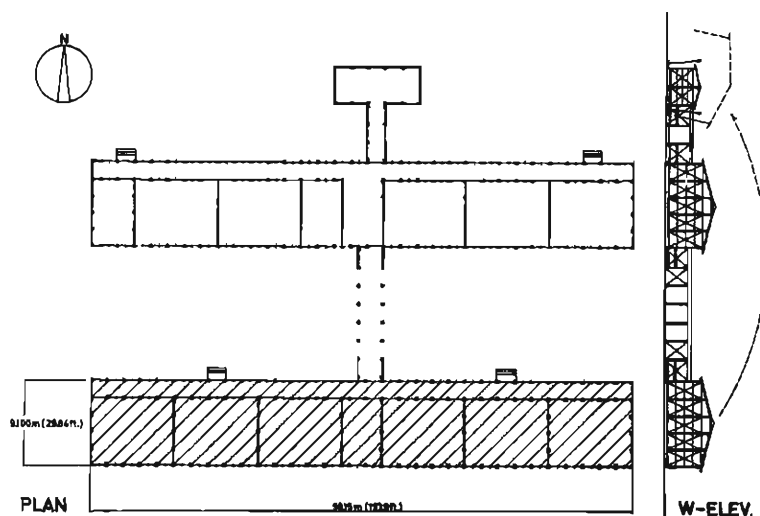
Fig. 5. The damage of a prefabricated school building caused by strong up-draft.

A prefabricated one-story school building situated the north of Ichikawa City was lifted up approximately 5 m, flown over and crashed down on the other side of

a neighbouring building which was 4.8 m in height (see **Photo. 3** and **Fig. 5**). The school building had 7 rooms and a floor area of  $9.1 \text{ m} \times 59.2 \text{ m}$ . The distance between the two buildings was 37 m. The floor boards of the school building remained intact and the desks in the rooms also remained as they were. The weight of the uplifted building including the side walls and roofs was about  $82 \text{ kg} \cdot \text{w}/\text{m}^2$ . It was found that the side walls were not sufficiently fixed to the floor boards or to the foundation of the building, therefore the building could be lifted up only by an up-lift force equivalent to the weight of the building.

These two special cases indicate that damage was caused by up-lift forces of short duration and therefore there were strong up-drafts.
